Manhole Inspection Summary

Manhole # S33WW1015MH

Insp Date: **1/24/07 2:28 PM**

Location Address: **5201 SPRINGLAKE WAY**

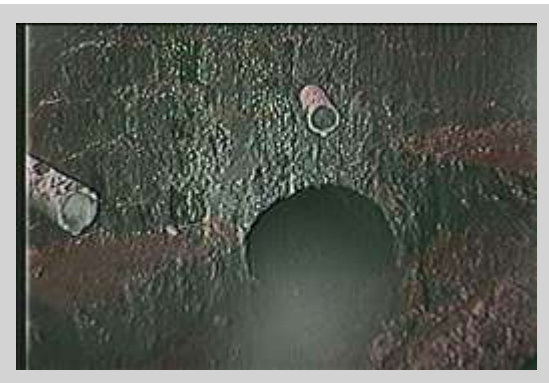
8 in. Circular Gravity Sewer Pipe In @ 3 O'Clock

Pipe Material: **Clay** ☐ Pipe Lined

Infiltration: **None** Pipe Seal Cond: **Unknown**

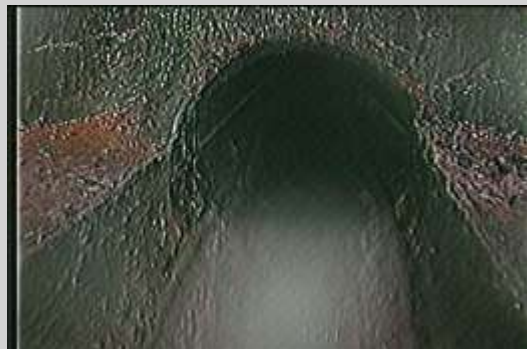
12 in. Circular Gravity Sewer

Pipe Material: **Unknown**

Infiltration: **None**
